# National Weather Service Des Moines

## Storm Storm Survey

### Bradgate and Rolfe Tornadoes of May 22, 2004

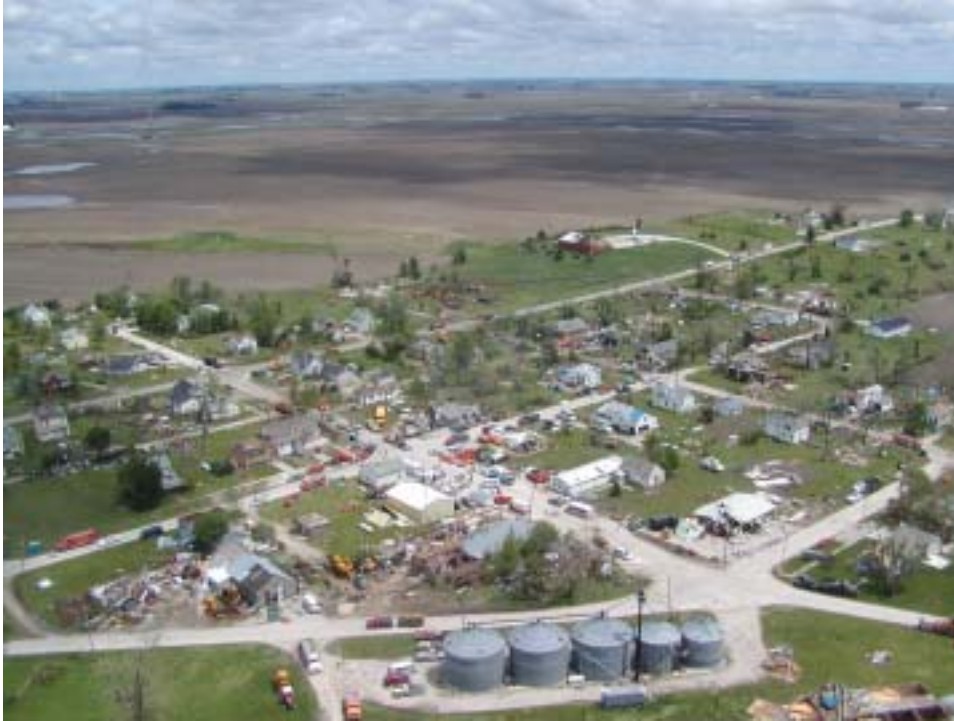
Aerial photo of Bradgate looking northeast

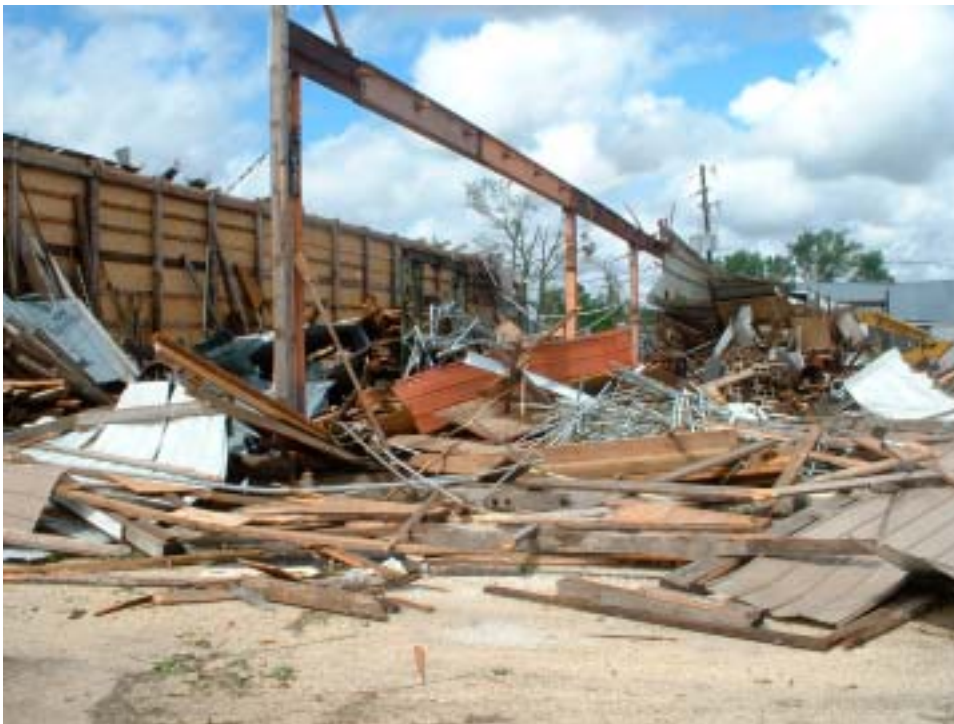
Garage, or lightly constructed structure, which suffered collapse (F1).

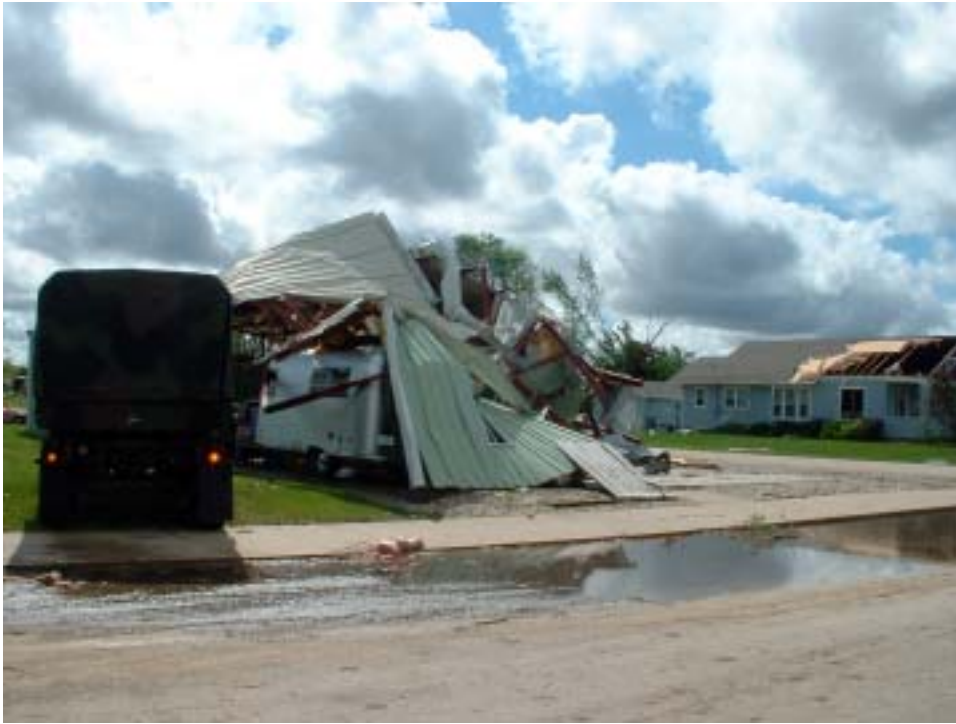
Looking southeast from the center of town. A garage destroyed in foreground and roof damage in the background. (F1).

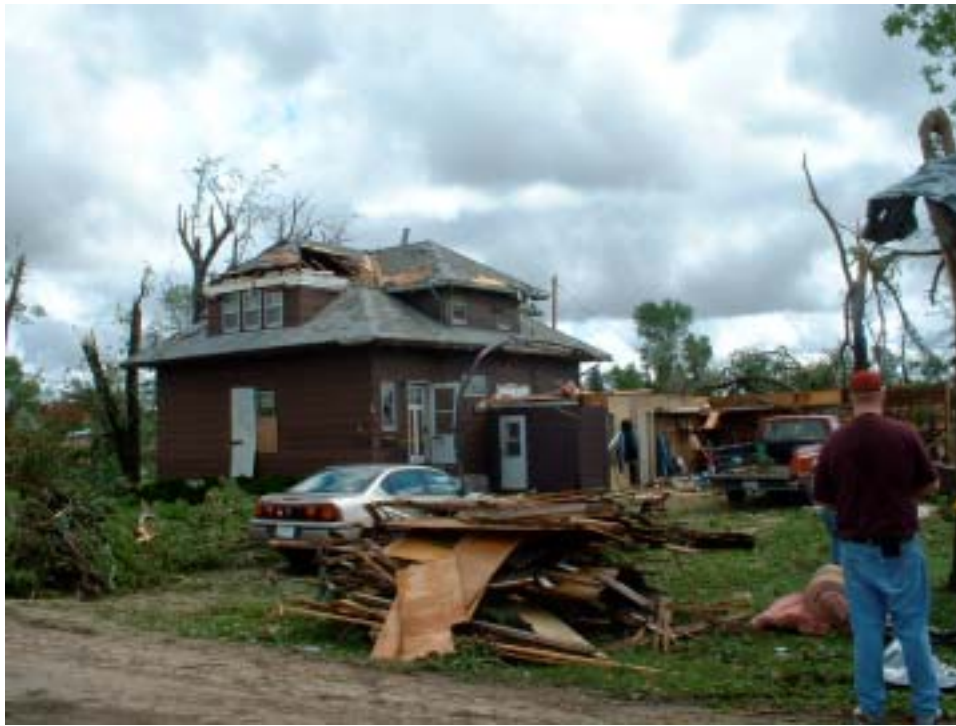
Looking east from east side of town. Home with garage destroyed but main home with minor damage (F1).

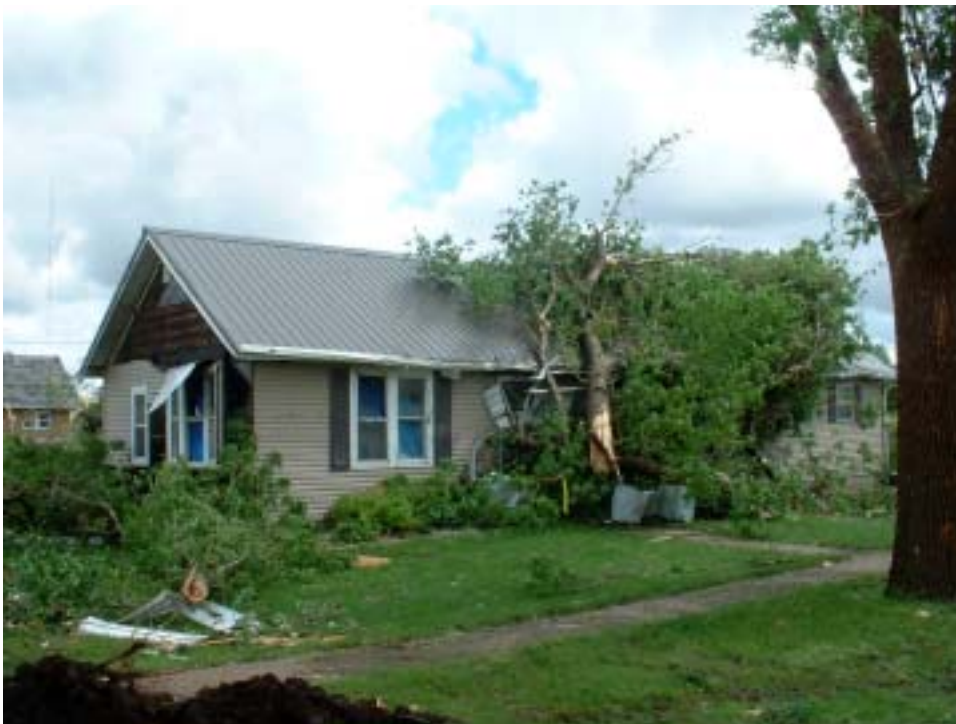
Looking northeast on northeast side of town. Home with tree down on it (F0).

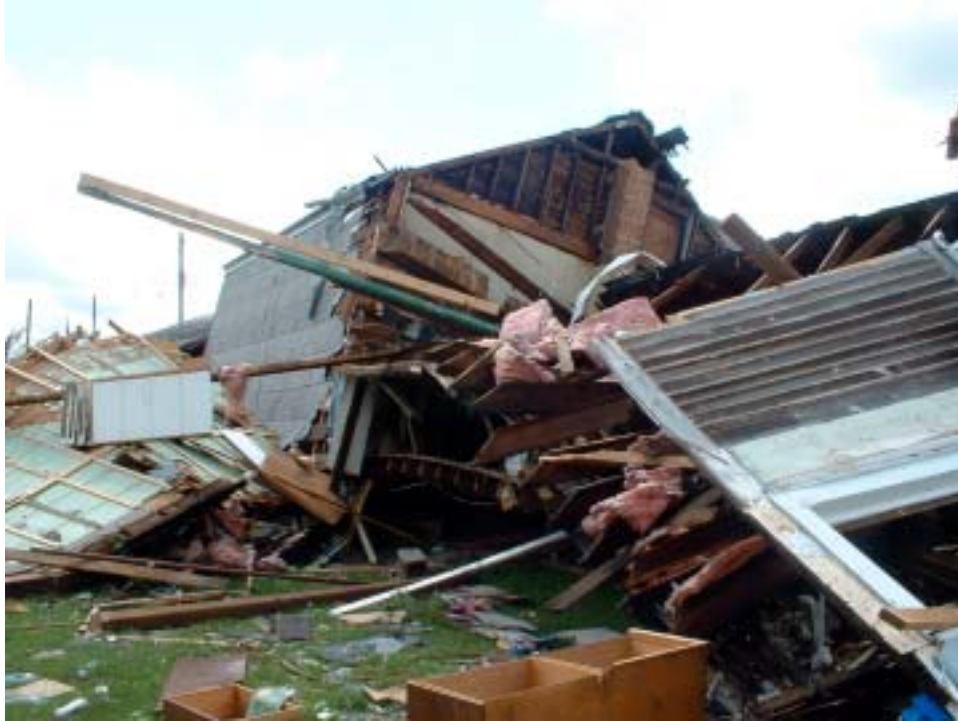
Looking south at home on the north side of town. Home destroyed with roof gone. Home was “twisted off” foundation resulting in failure (F2).

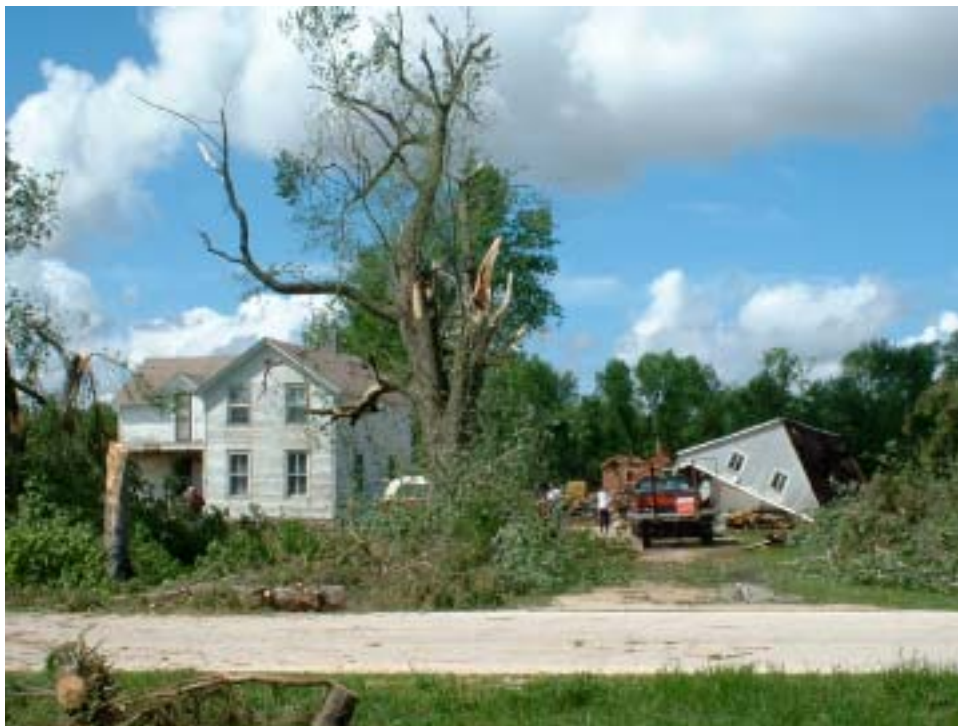
Looking south from southwest corner of town. Garage destroyed with tree damage. Minor damage to home (F1).

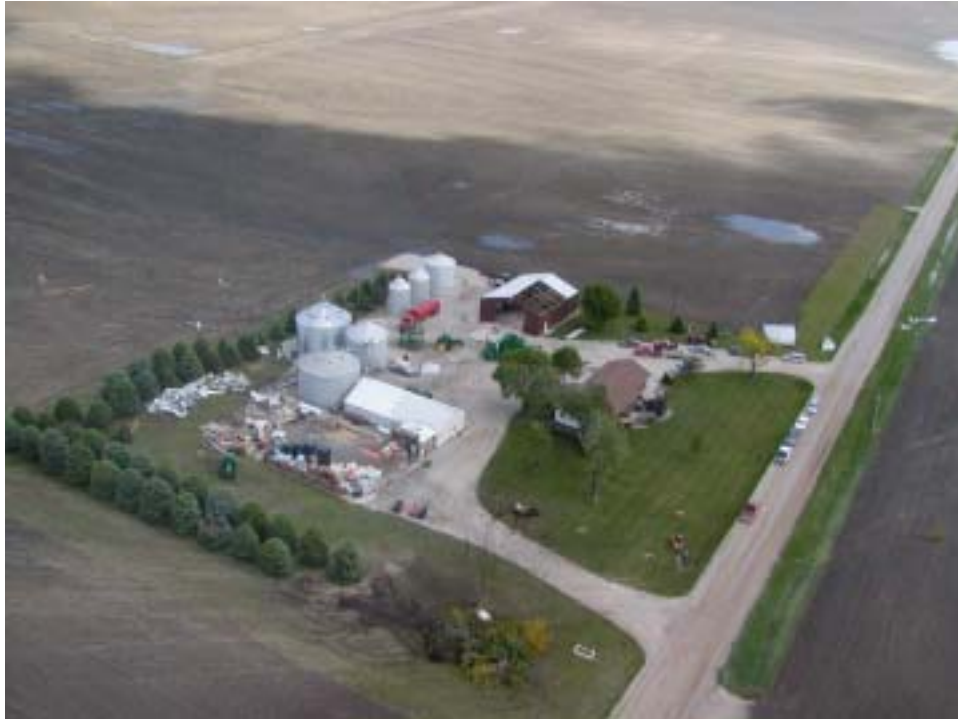
Aerial from the Rolfe vicinity looking northeast

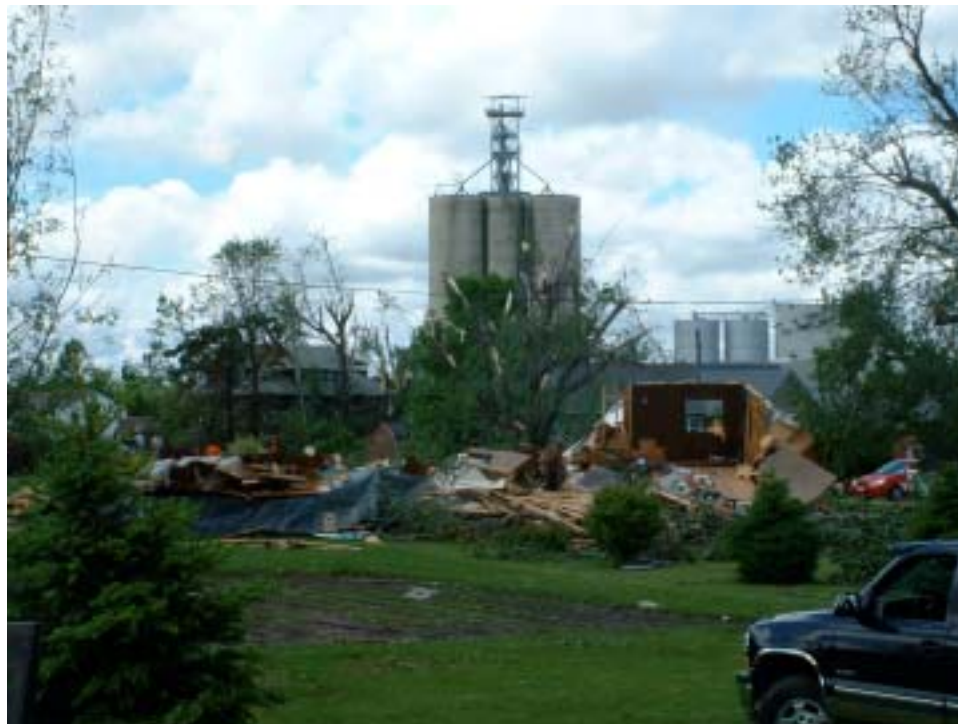
Looking south from northeast corner of town. Home which suffered complete failure. Note lack of major damage next to home which resulted in F2 rating (F2).

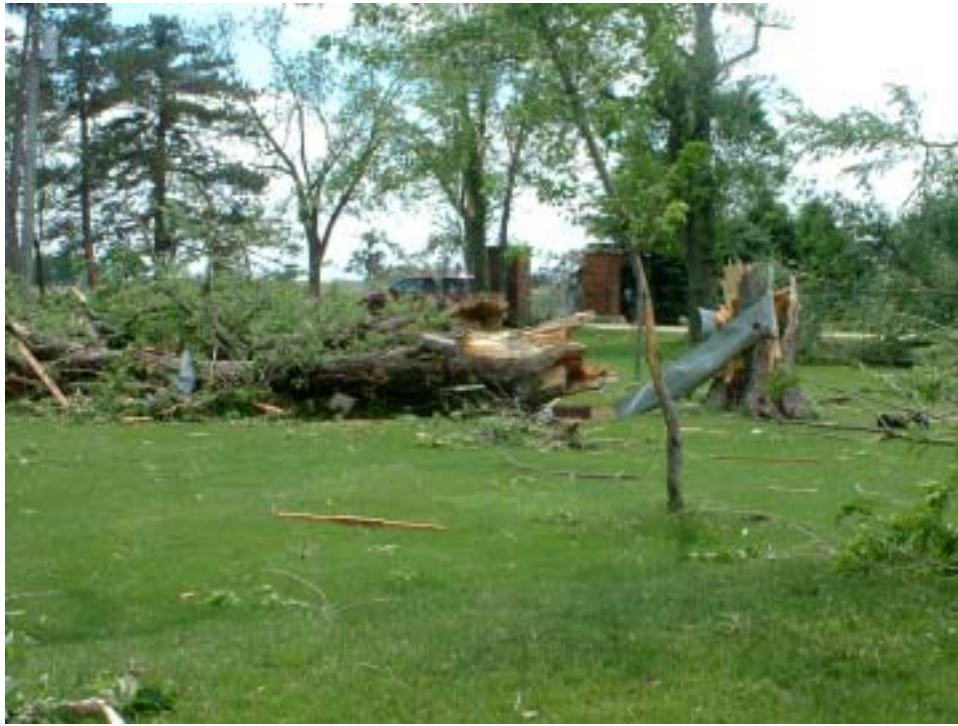
South of town looking south, just east of golf course. Large tree snapped. Tree had some soft tissue or rot (F1).
